# THE CASE OF THE

## 'MISSING' HAGO

ZVI MERCHAV, MERCHAV ENGINEERING, ISRAEL, AND FRED JUSTICE, CHEMSTATIONS, USA, INVESTIGATE THE PROCESS OF TROUBLESHOOTING A CRUDE UNIT MAIN COLUMN AT A REFINERY.

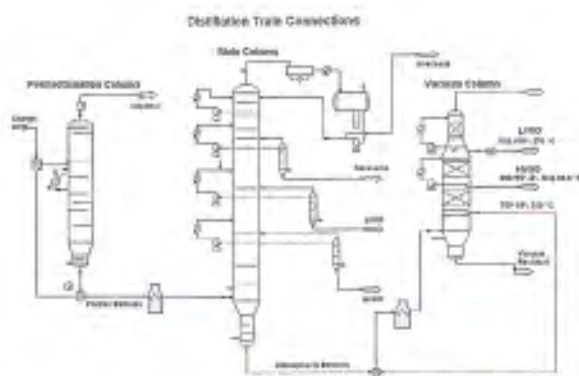
**Figure 1.** Flowsheet diagram showing configuration of columns.

The vacuum system was also modified to allow the usage of velocity steam in the vacuum heater and the introduction of stripping steam to the vacuum column bottom. Figure 1 shows the arrangement of the preflash main and vacuum columns, and Table 1 gives a summary of the columns.

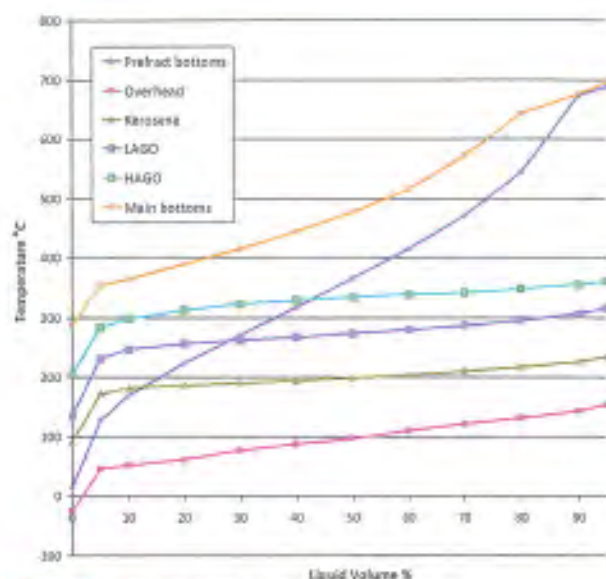
**Figure 2.** Main D86 distillation curves.

The distillation curves for the feed and other streams of interest are plotted in Figure 2. The product yields and specifications were as predicted and expected by the customer.

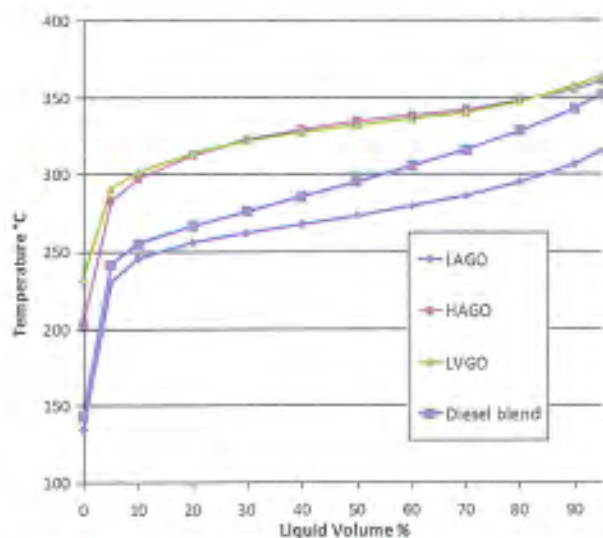
**Figure 3.** Diesel blend D86 distillation curves.

Diesel product is usually a blend of three crude unit products: light atmospheric gas oil (LAGO), heavy atmospheric gas oil (HAGO) and light vacuum gas oil (LVGO). The proportion of the blend is varied to meet a particular product specification, which can vary slightly depending on its usage during winter or summer. The typical stream distillation curves are shown in Figure 3.
